UNDERPINNING COMPACTION GROUTING

LOWELL GENERAL HOSPITAL

CASE STUDY | UNDERPINNING

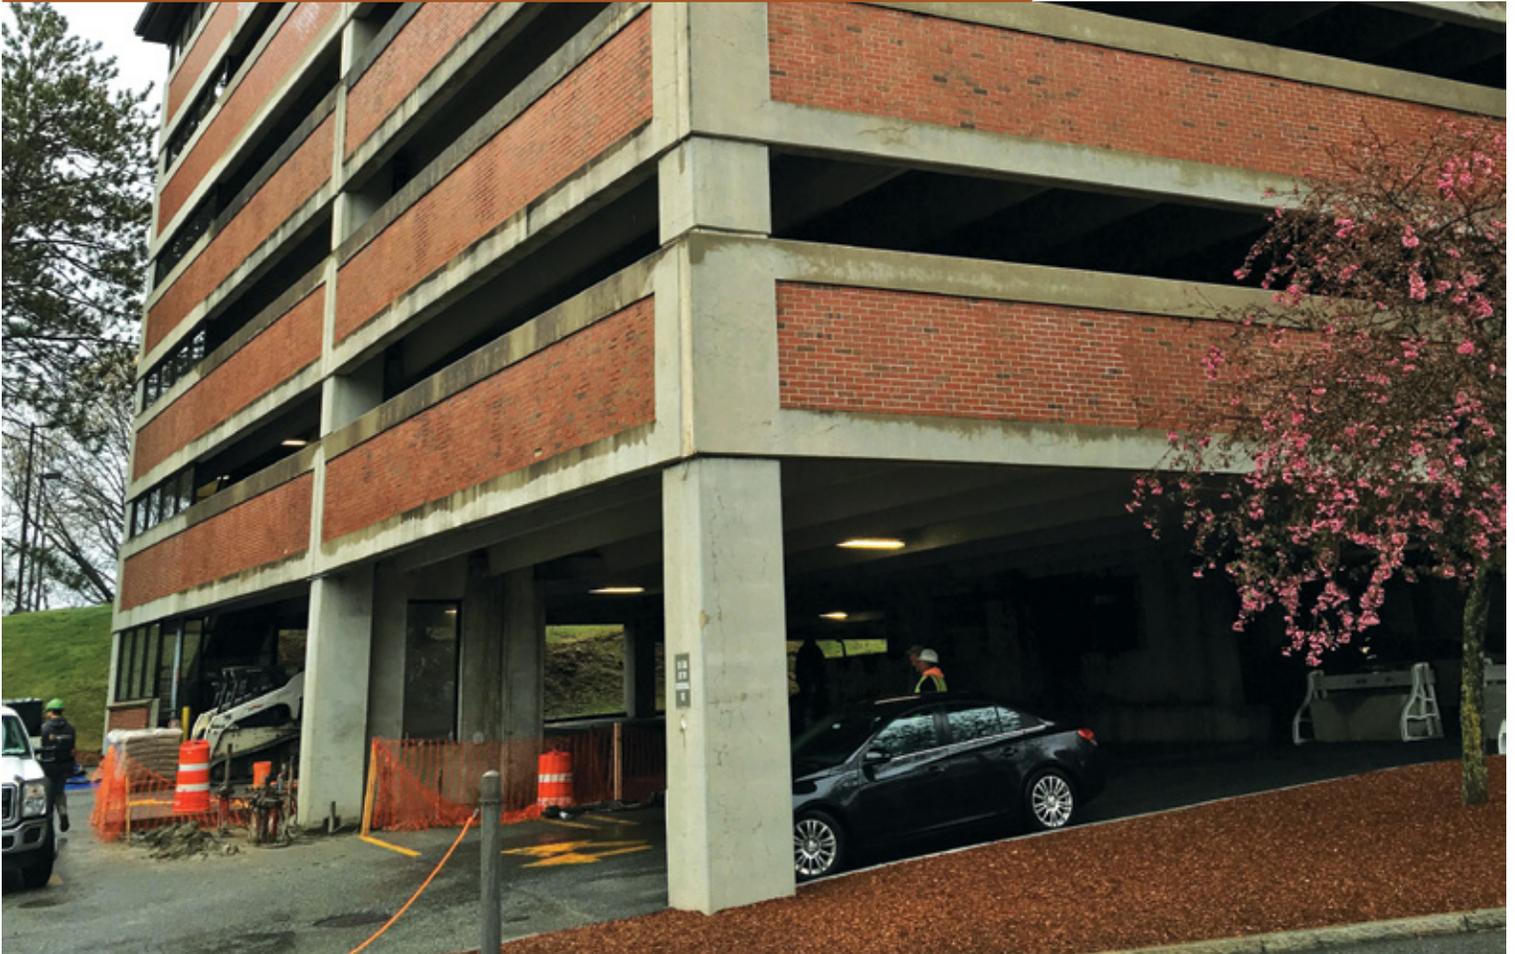
In order to fully support the 17-foot wide by 25-foot long spread footing, compaction grout points were positioned in a grid pattern throughout the footing footprint. The temporary steel casing was driven through cored holes in the footing, through the very loose to loose sand fill, and into the underlying natural, medium dense sand layer. The compaction grouting mix was batched on-site and consisted of a low-slump Portland cement-based grout. Compaction grout columns were constructed as described above, creating an improved soil matrix capable of supporting of the footing without further settlement.

Rather than removing and replacing the existing footing, Helical and the team implemented a compaction grouting underpinning solution that allowed for the existing footing remain in place, a fast construction schedule, and a much lower cost.

Helical completed the compaction grout column underpinning in just three production days.
